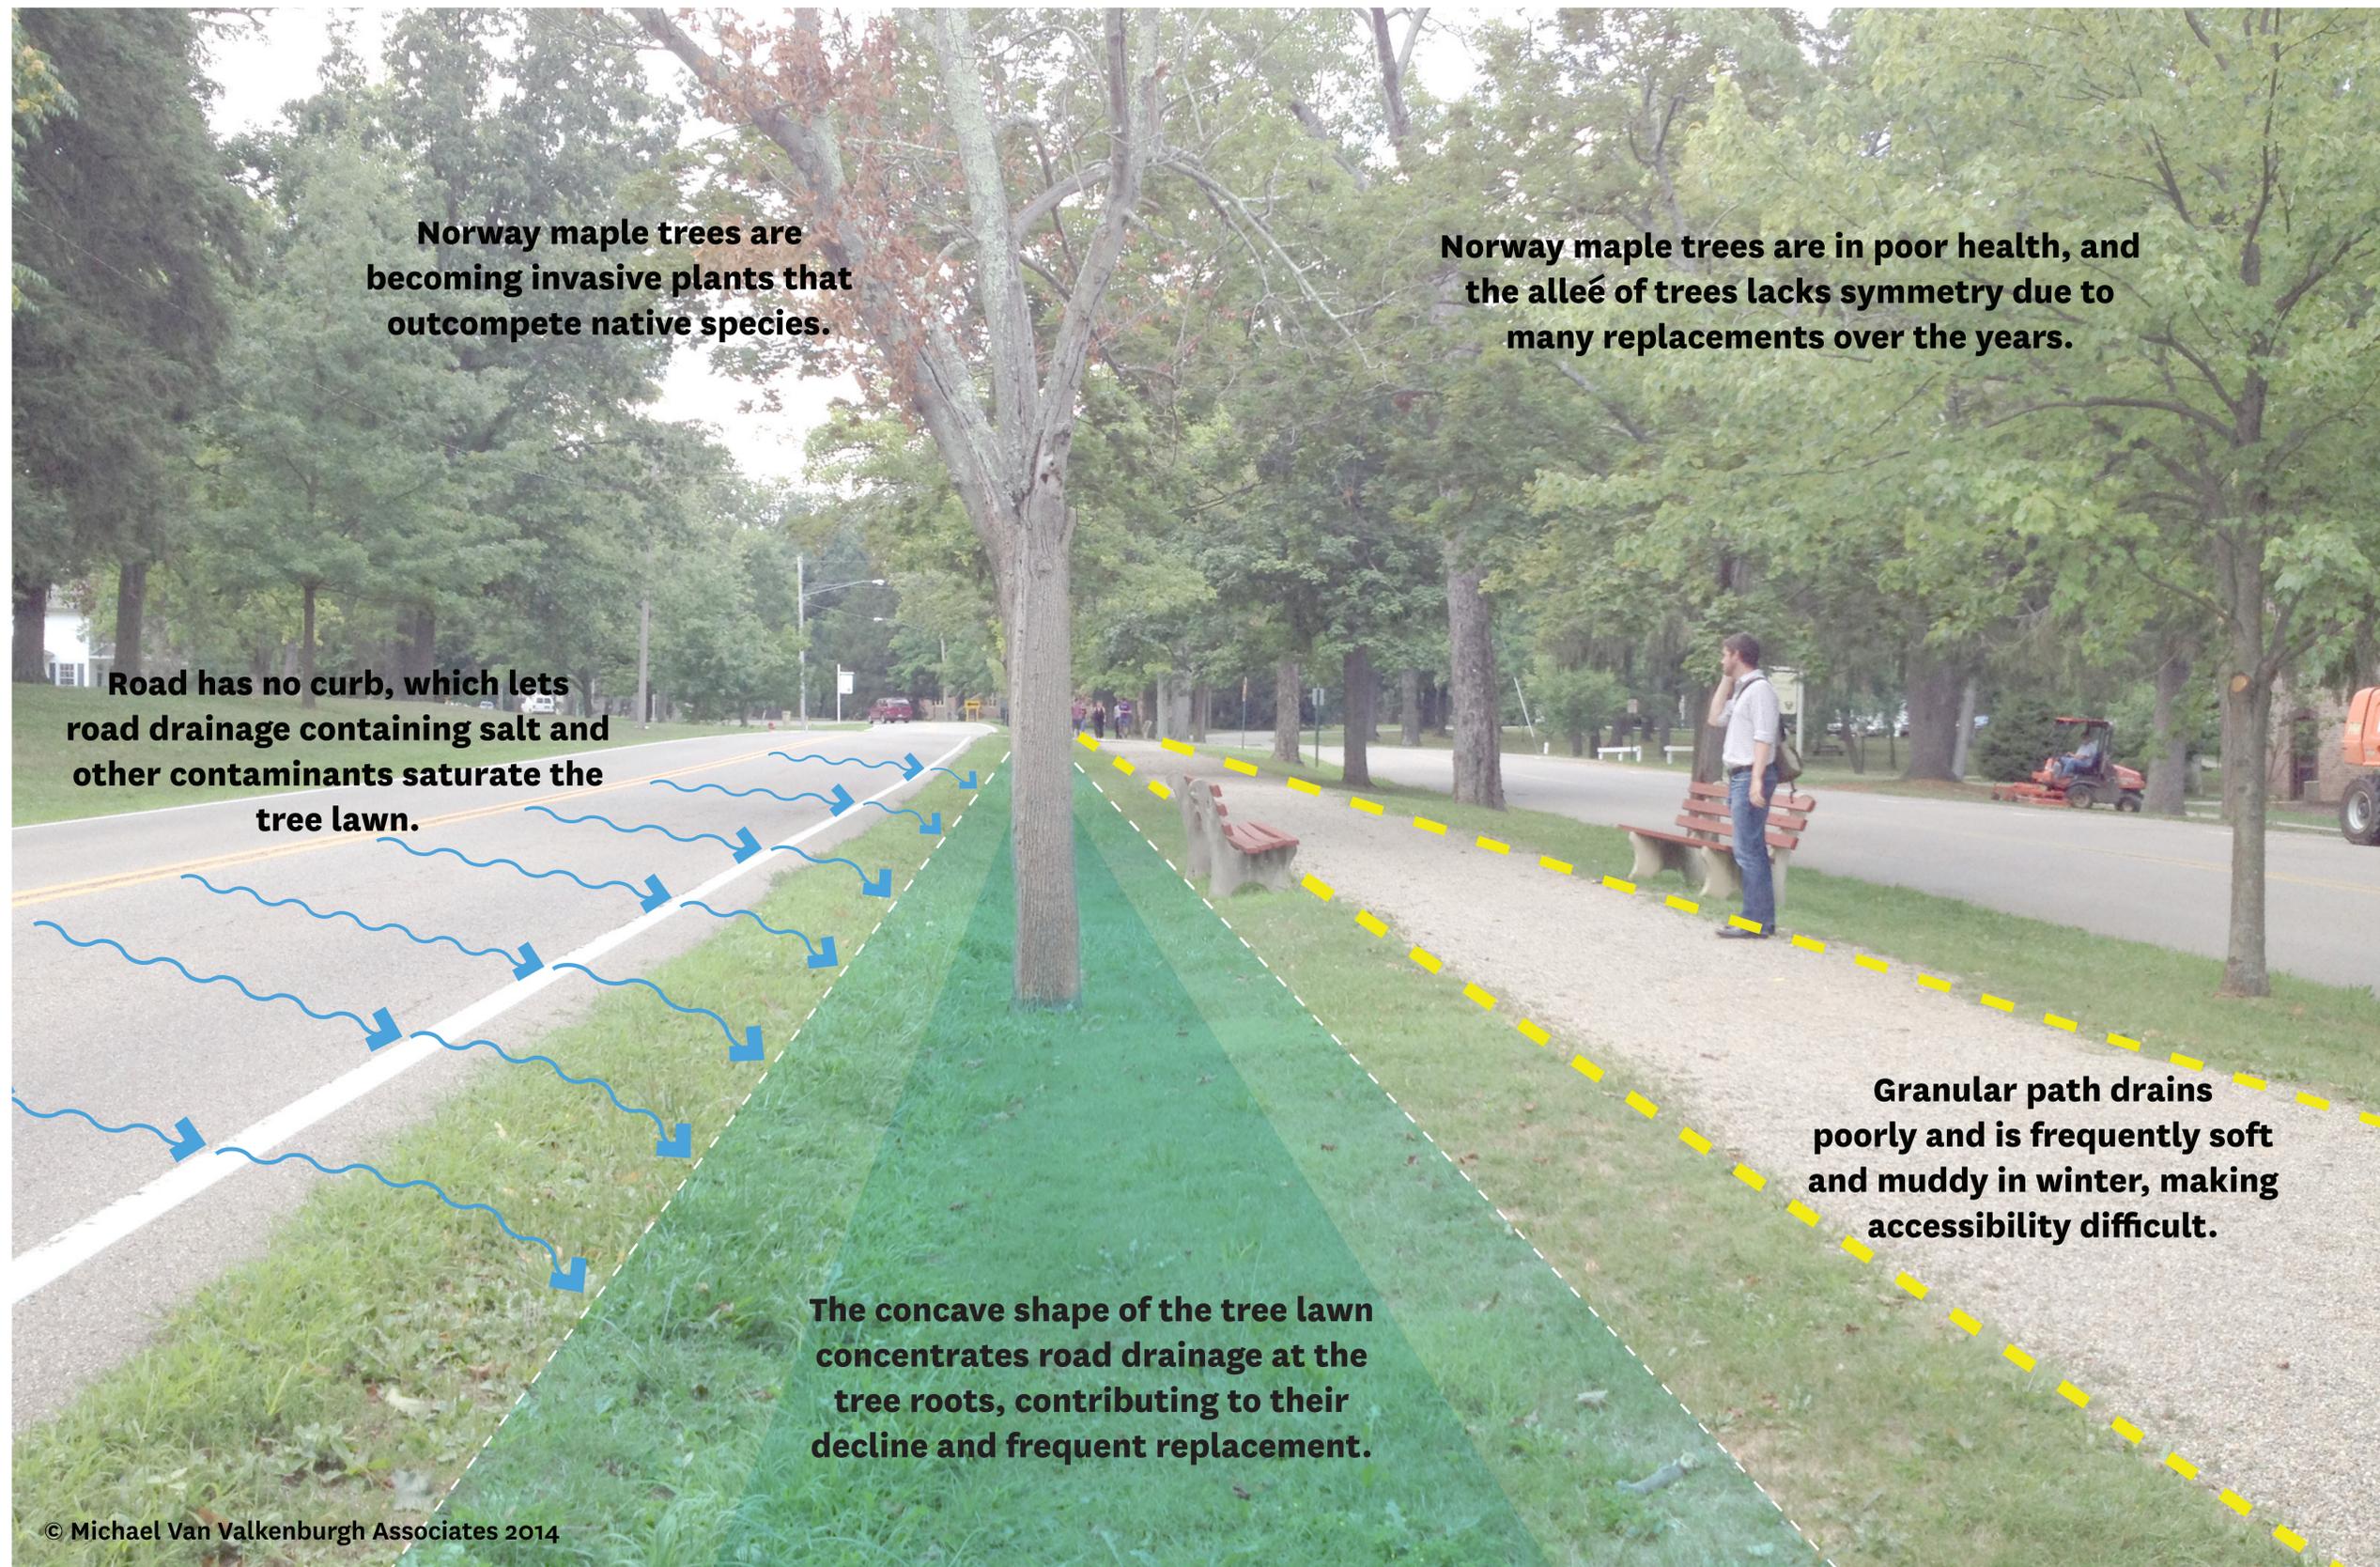
Norway maple trees are becoming invasive plants that outcompete native species.

Norway maple trees are in poor health, and the alleé of trees lacks symmetry due to many replacements over the years.

Road has no curb, which lets road drainage containing salt and other contaminants saturate the tree lawn.

Granular path drains poorly and is frequently soft and muddy in winter, making accessibility difficult.

The concave shape of the tree lawn concentrates road drainage at the tree roots, contributing to their decline and frequent replacement.
